ROUTE 2 ASSESSMENT – Pembury to Tunbridge Wells via the A264

Route Start Point: Pembury High Street / the Green **Route End Point:** A264 Pembury Road Junction with Calverley Park Gardens

Route Distance: 2.1miles (3.3km)

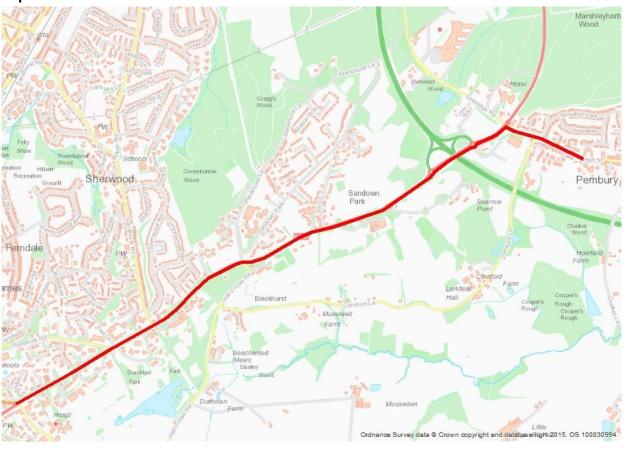
Route Map

Description: The route follows the alignment of Pembury High Street and the A264 Pembury Road. A broadly flat route that utilises both on road and segregated infrastructure of varying quality. The route forms part of National Cycle Route 18 through Tunbridge Wells. Locally the route has an urban utility function, which connects Pembury and Tunbridge Wells with The Skinners Kent Academy.
